May 17, 2007

Regarding: Report for AMEC Proposal No. PN07-2-2; Environmental Protection Agency (EPA), National Emission Standard for Hazardous Air Pollutants (NESHAPS), Limited Supplemental Asbestos Containing Material (ACM) Survey Prior to Future Demolition of the Gabbs Old Recreation Hall, Located at 531 Avenue E, Gabbs, NV.

Sato Environmental Project #210-01

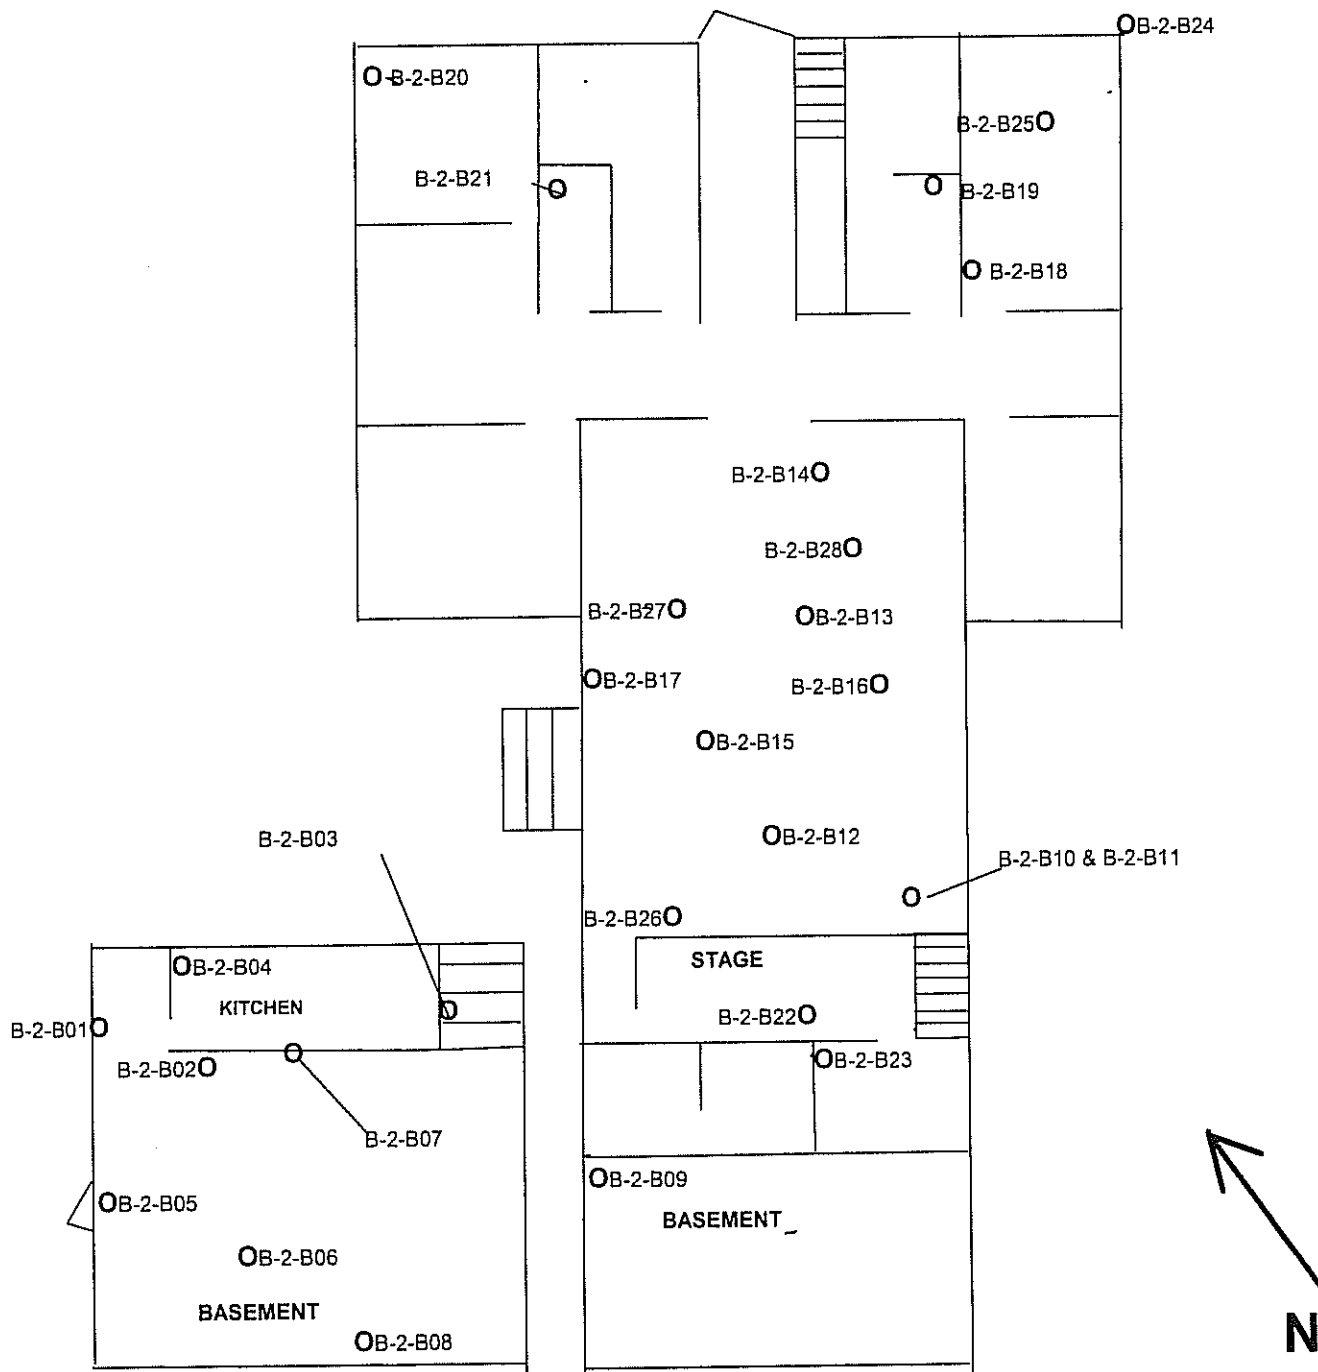
Gabbs Recreation Center
531 Avenue "E", Gabbs, Nevada
 O-----ACM Sampling Locations

BUILDING FOOTPRINT is APPROXIMATE and for
 GENERAL REFERENCE ONLY; NOT-TO-SCALE
